**U.S. DEPARTMENT OF DEFENSE
Environmental Security Technology Certification
Program (ESTCP)**

Final Report

**Electrospark Deposition for Depot- and
Field-Level Component Repair and
Replacement of Hard Chromium Plating**

Project WP-0202

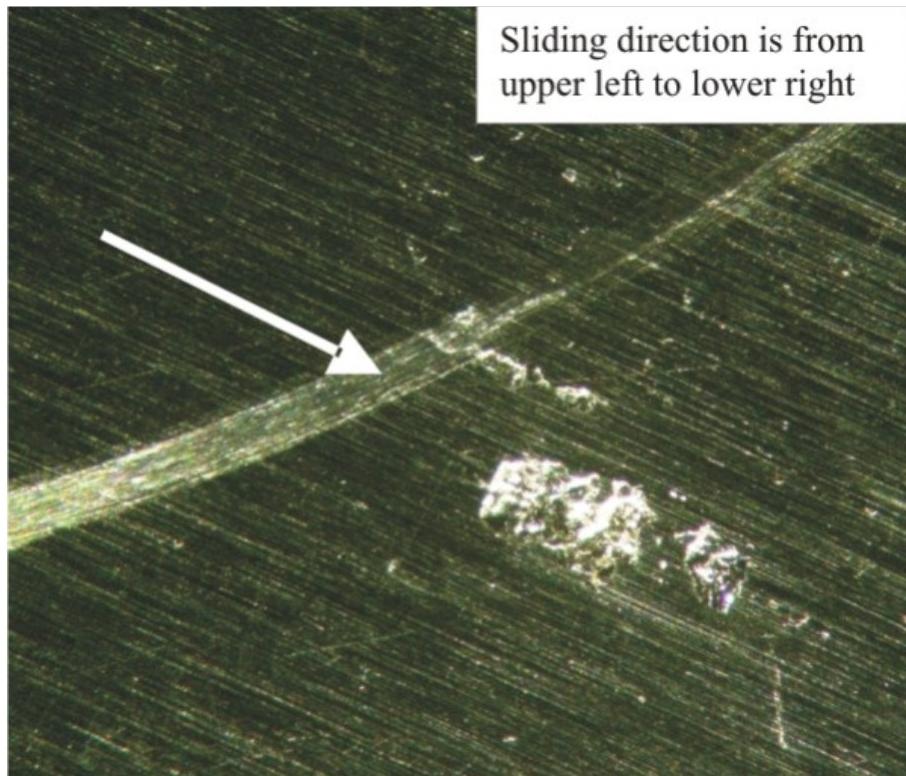
Figure 4-71 Wear Groove Encountering ESD Void

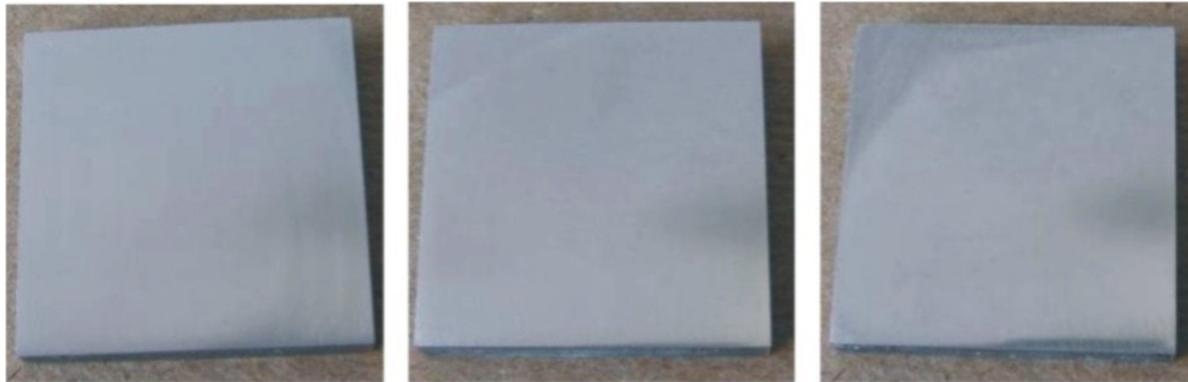
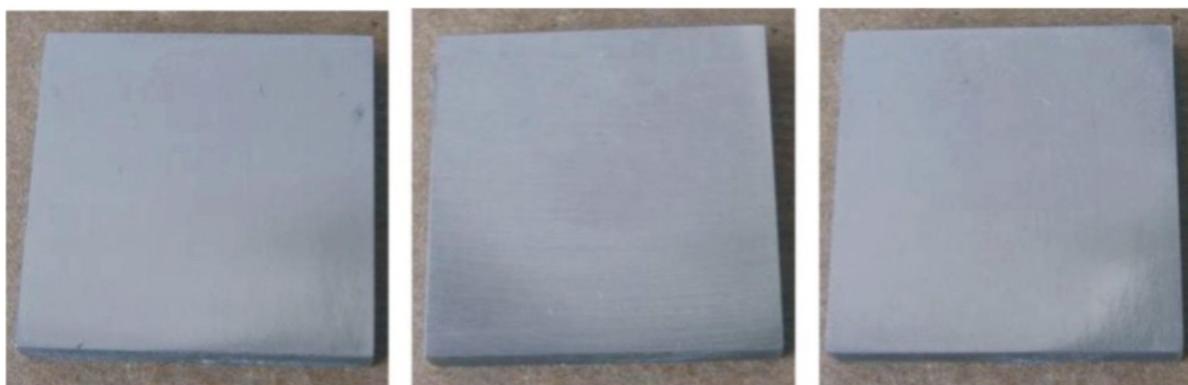
Figure 4-92 Corrosion Specimens 11-19 Following 168 Hours Salt Fog Exposure

Corrosion coupons #11–19 following 168 hours of salt fog exposure are shown in Figure 4-92. No corrosion was observed either inside or outside the ESD-repaired areas. It was not possible to visually determine where the ESD-repaired area was, so the coupons were etched following standard etching procedures for IN718 to visually show the location of the ESD-repaired areas and these specimens are shown in Figure 4-93.

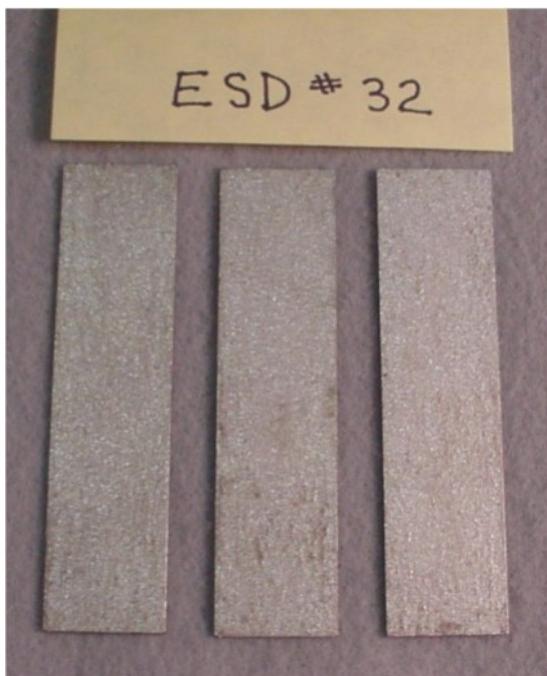
Figure 4-95 ESD #32 on Almen strips

Almen strips treated with #32 parameters are shown in Figure 4-95, with the treated sides facing out of the page. These strips were curved inward (concave), indicating tensile stresses were produced by the ESD process. Almen strips treated with #V4 parameters are shown in Figure 4-96, and also show tensile stresses. The magnitude of the stresses, indicated by the amount of curvature, was measured with a Mitutoyo digital height gauge, as shown in Figure 4-97. Deflection data are shown in Table 4-34 and Figure 4-98 for ESD treated Almen strips (no UIT).

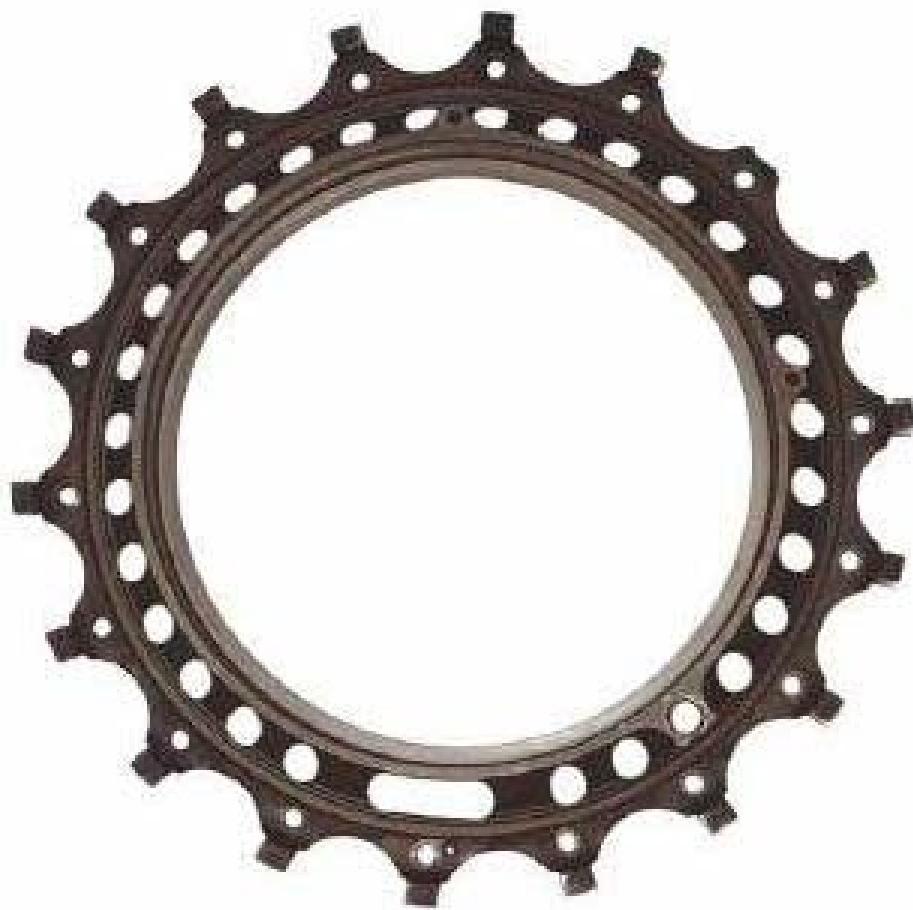
Figure 4-101 #5 Bearing Housing

The #5 bearing housing is shown in Figure 4-101. This component is subject to different types of damage in service, of which all are potential candidates for development of an ESD repair. As can be seen in the figure, one of the lugs is missing. This was due to a failure that was potentially the result of an undercut weld in a process used to hardface the lugs. This project did not address that issue; however, discussions with OC-ALC indicate that ESD may be used in that application in the future. This project addressed

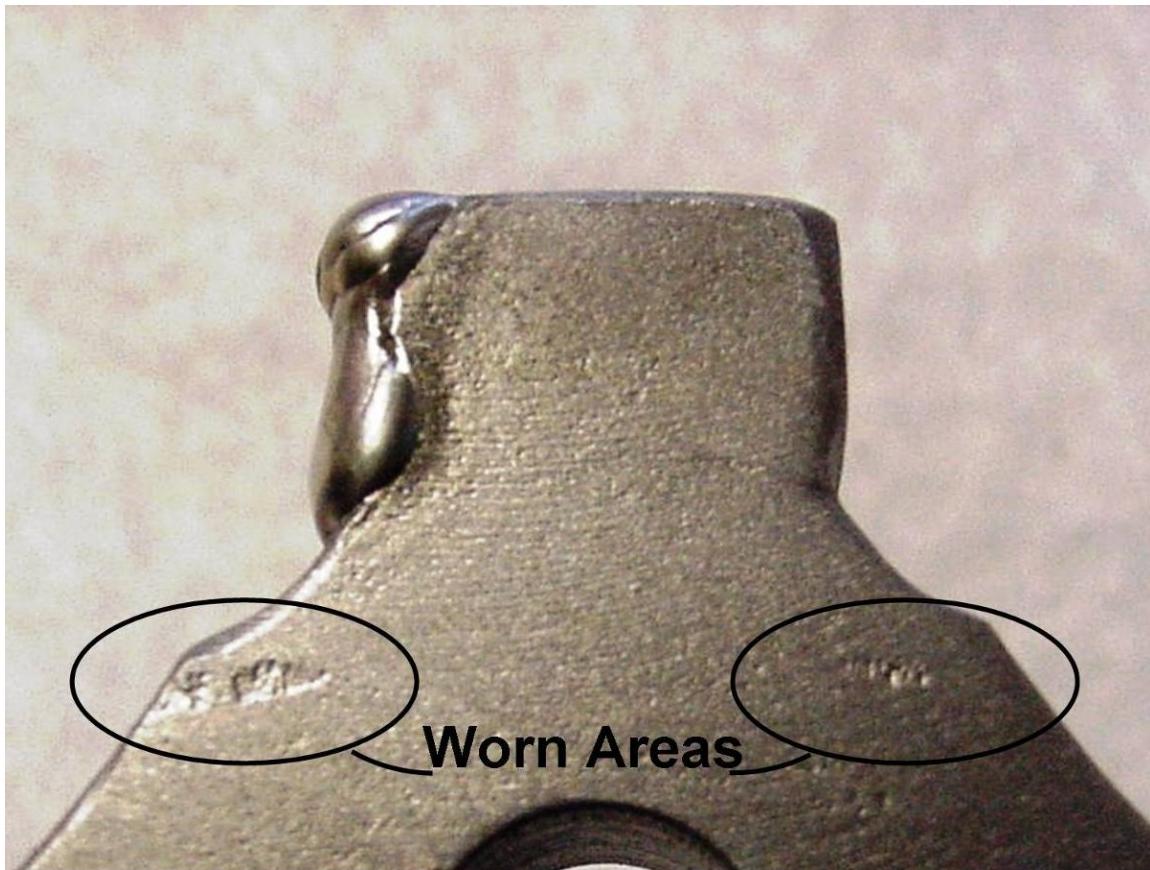
the repair and dimensional restoration of the wear scars that occur on the front face of the housing (loss of material due to wear), as seen in Figure 4-102.

Figure 4-102 Damaged Area to Receive ESD Repair

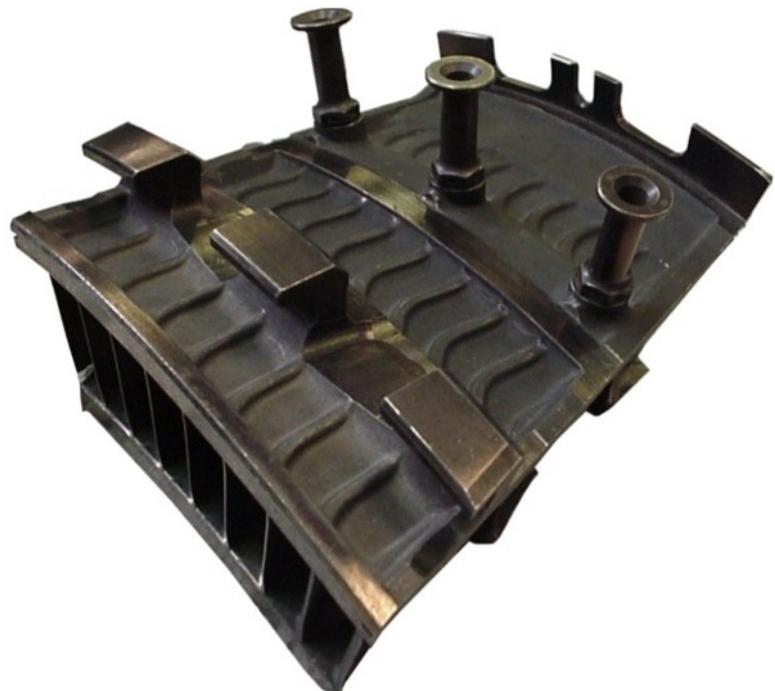
Figure 4-110 10-12 Stator Segment

The 10-12 stage stator segment is shown in Figure 4-110. The problem is deep wear scars that occur on the underside of the “hook” as shown in Figure 4-111. There are three hooks per stator segment and all three exhibit the same wear patterns.

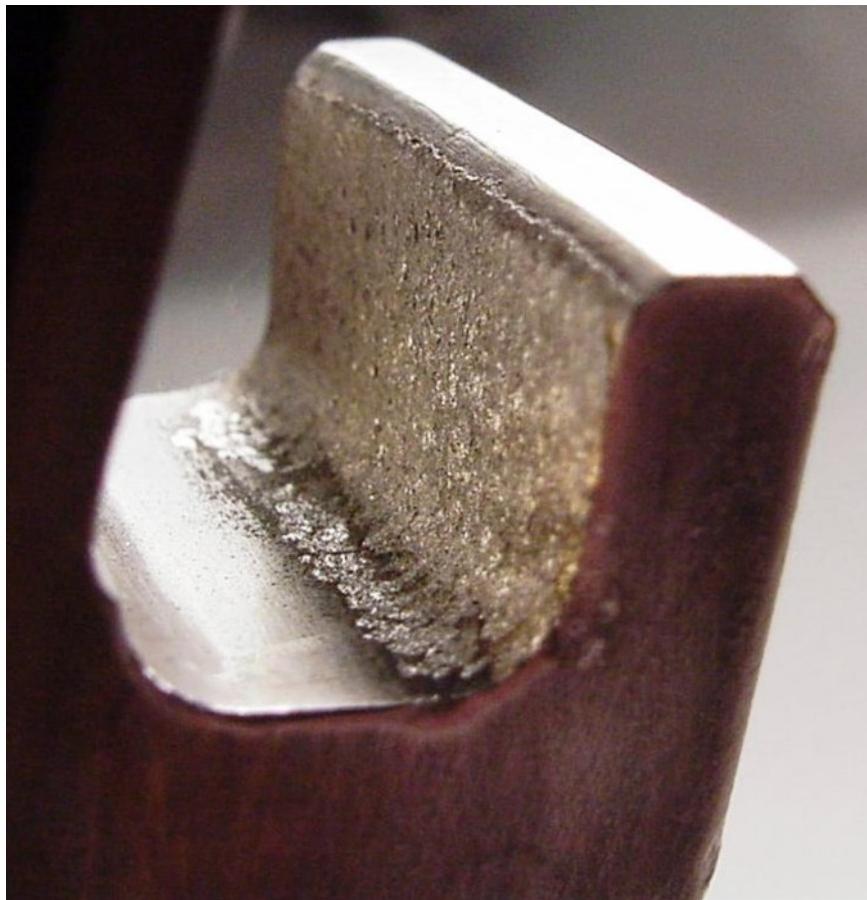
This area was difficult to access and deemed a non-line-of-sight application. However, using unique ESD techniques and a custom applicator head, the area was excavated and repaired. The repaired area is seen in Figure 4-112.

Figure 4-112 Repaired Area on 10-12 Stator Segment

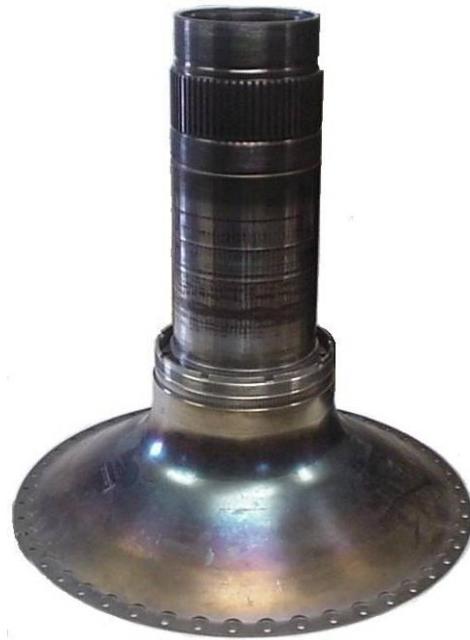
Figure 4-113 TF39 Shaft

The compressor rear shaft is shown in Figure 4-113. There are a number of reasons why this component is either rejected during the repair process or removed from service, including:

- Area did not chrome plate completely.
- Dents on the surface.
- Unsuccessful plating (chrome not adhering).
- Diameters undersized, with no rework procedure available.
- Air erosion on flange surface.

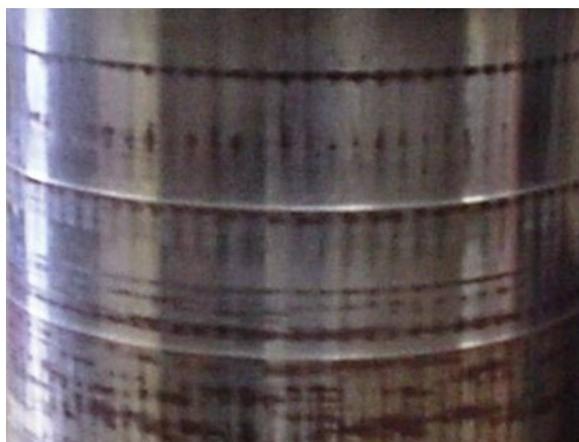
The major issues are dents or scratches in the hard chrome plate on the journal and incomplete or damaged chrome plating on the “step”. Figure 4-114 reveals a severely worn chrome surface on the journal but does not show a particular dent or scratch. A close-up of the “step” area on the journal is shown in Figure 4-115. Another issue detected on this component was hot air erosion damage in the underside of the flange at the base of the component (Figure 4-116). All of these types of damage are candidates for ESD repair.

Figure 4-114 Worn Chrome Surface on Journal of TF39 Shaft

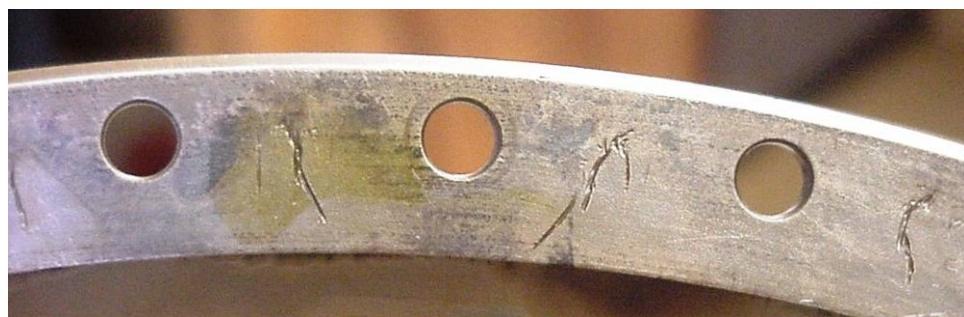
Figure 4-116 Hot Air Erosion on flange of TF39 Shaft

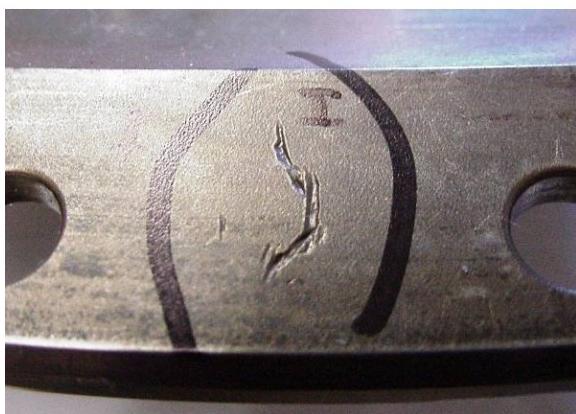
Minimal process development was conducted on repairing the hot air erosion damage. The width of the damage was approximately 0.03" and approximately 0.014" deep (Figure 4-117). The repair (Figure 4-118) was performed with no pre-ESD surface preparation (no excavation of the defect prior to repairing it). The ability to affect this repair with no surface preparation is somewhat revolutionary. The metallography of the repaired area (Figure 4-119) showed a complete fill, good interface and good density of the deposit.

Figure 4-117 Hot Air Erosion Defect

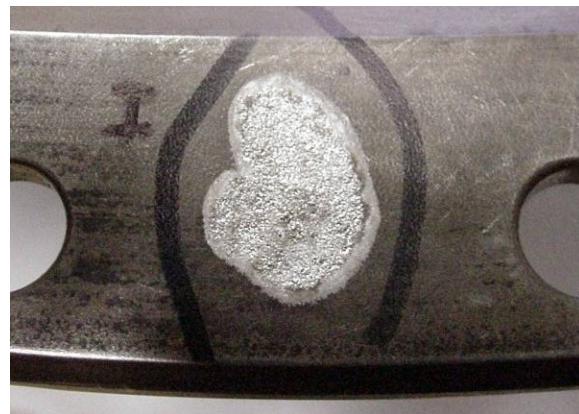
**Figure 4-118 ESD Repair of Defect
(Before Surface Finishing)**

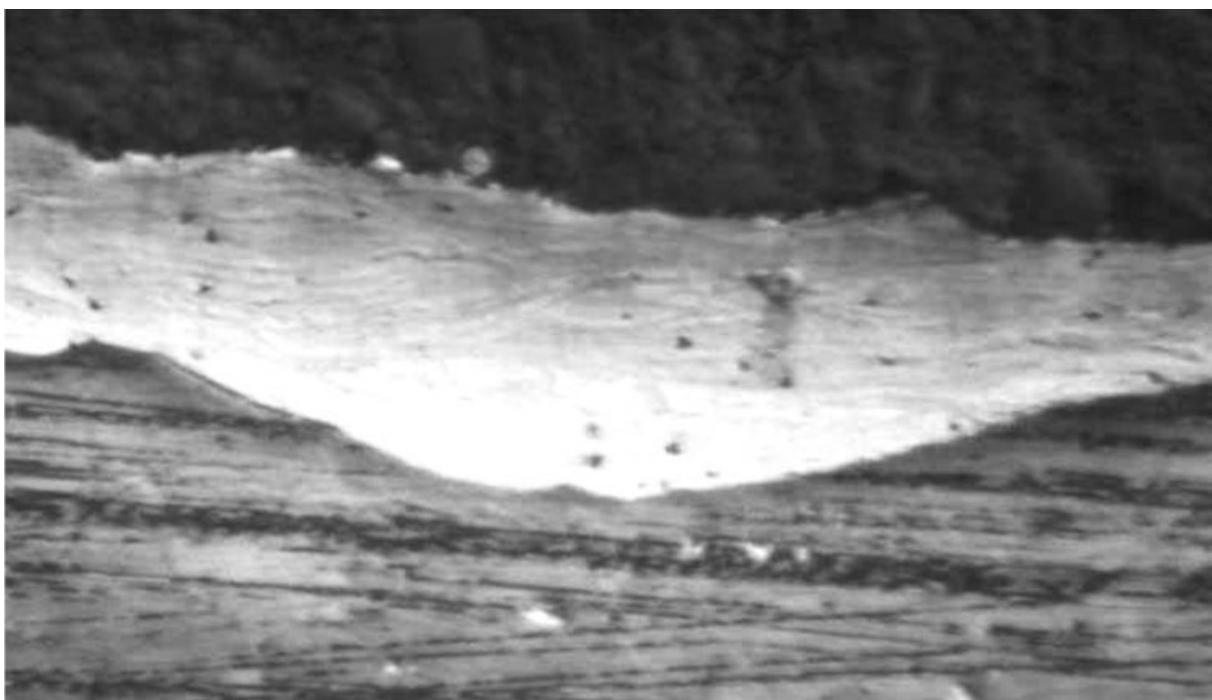
Figure 4-119 Metallography of Repaired Hot Air Erosion

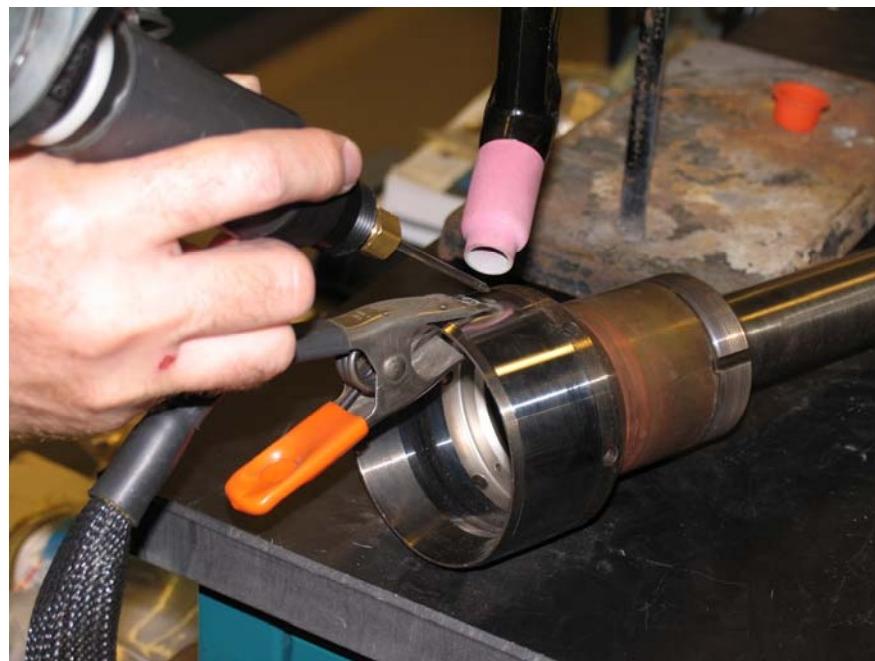
Figure 5-20 ESD Repair Being Performed at ARL on an Actual Helical Gear Shaft Containing Defects

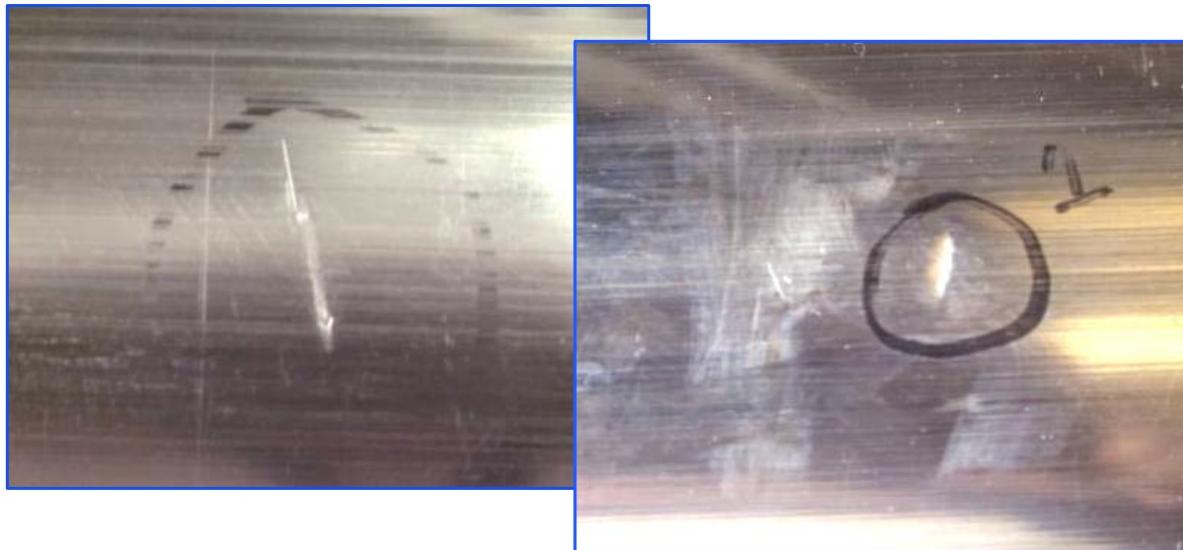
Figure 6-2 Examples of damage on Steering/Diving Control Rod Sustained in Service

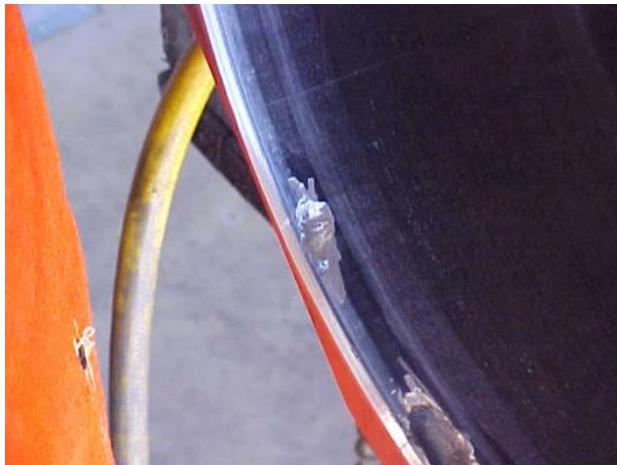
PITS PREPARED FOR ESD REPAIR

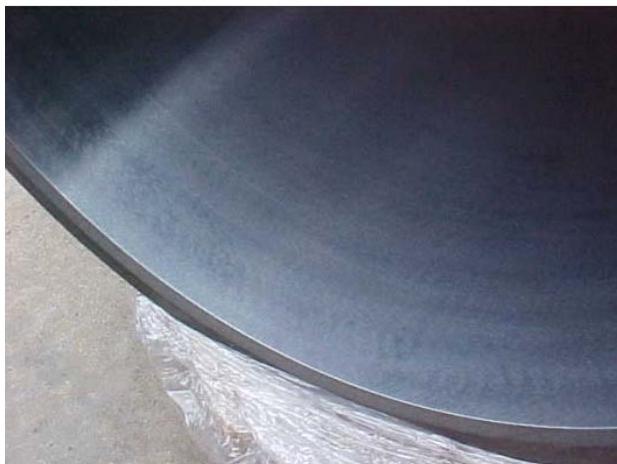
AFTER ESD REPAIR, CHROME PLATING, AND FINISH GRINDING

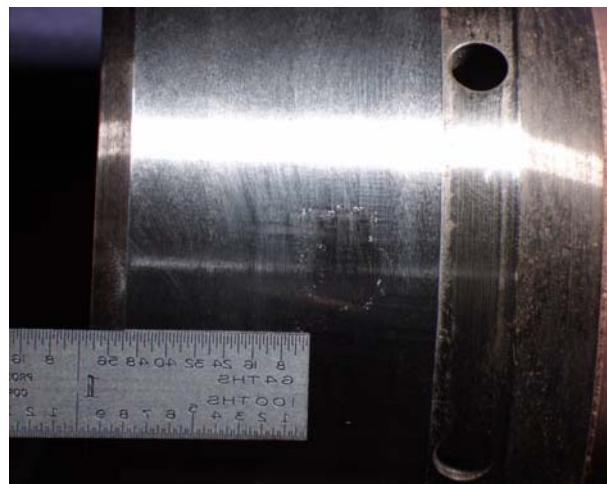
CORROSION PIT AFTER ESD REPAIR AND FINISH GRINDING
